June 5th, 2017

Teck Highland Valley Copper
P.O. Box 1500,
Logan Lake, BC
V0K 1W0

Re: May 9th-11th MEM Inspection Report 75277

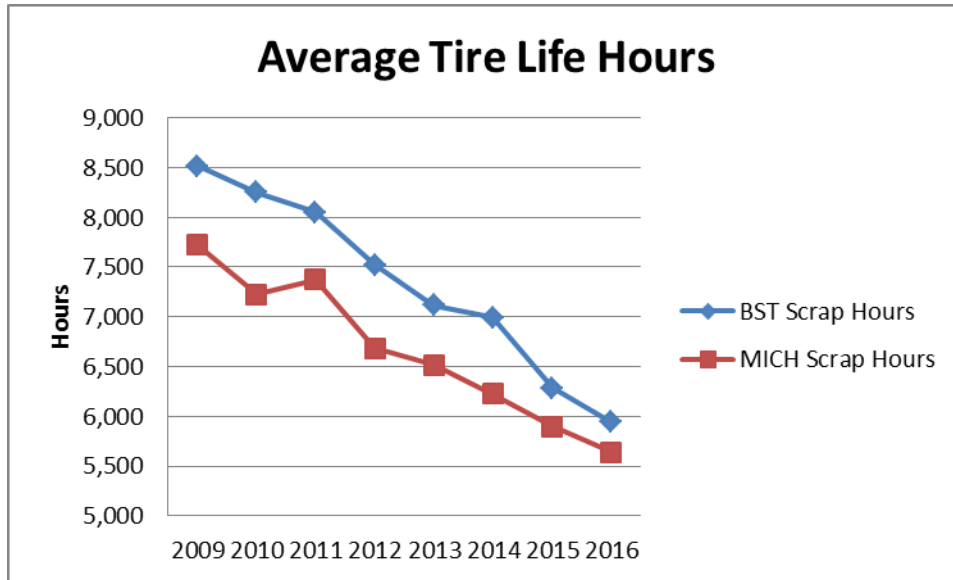
Figure 1: Average Tire Life Hours

Tire life, which can be used as a road condition indicator, has declined most notably in the last two years. Mechanical availability for the 16M graders decreased 21% and the rubber tired loaders decreased 31% from 2016 to 2017 (January – April).
